DISTRICT 2 – COAL MINE NEAR MISS

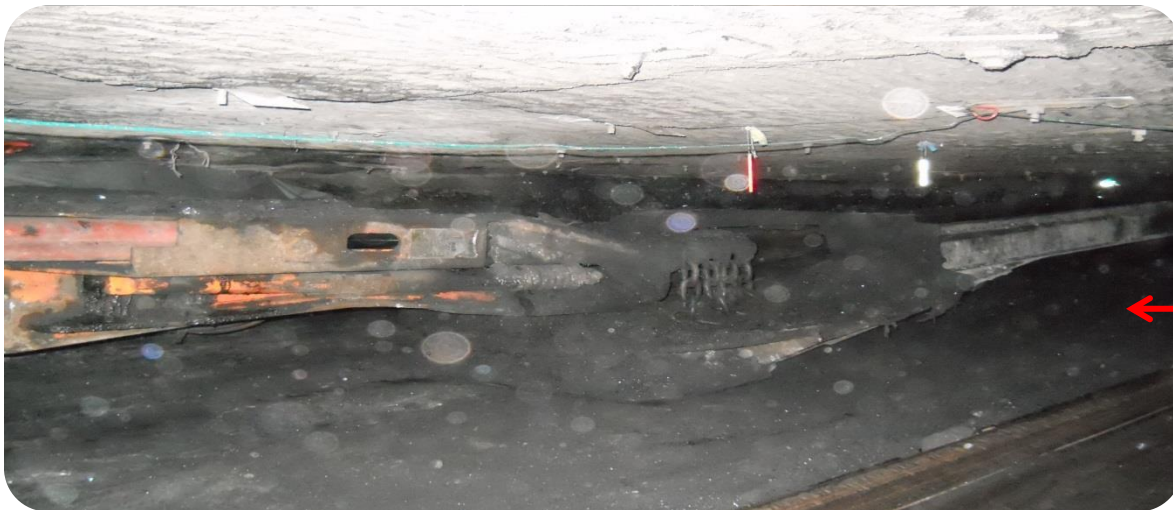
Miner
Operator
Location

On March 17th, 2016 a continuous mining machine operator was seriously injured when he was struck by a bridge conveyor. The machine operator crawled under a bridge conveyor that was attached to the tail of the continuous mining machine while it was in a raised position and energized. While crossing under the bridge conveyor the machine operator attempted to raise the continuous mining machine tail to continue tramming but accidentally lowered the tail, causing the bridge conveyor to strike him in the hip.

- Never perform work/travel under machinery that is in a raised position until such machinery is securely blocked.
- Install and maintain proximity detection systems to protect personnel and eliminate accidents of this type. See the proximity detection information page on the MSHA website (http://www.msha.gov/Accident_Prevention/NewTechnologies/ProximityDetection/ProximitydetectionSingleSource.as).
- Avoid "RED ZONE" areas when operating or working near mining machinery.
- "Panic Out" the continuous haulage system before crossing over/under.
